Manhole Inspection Summary

Manhole # S37I__004MH

Inspection ☐ Is Incomplete Rating: **4) Poor**

Location Address: **201 e pratt st**

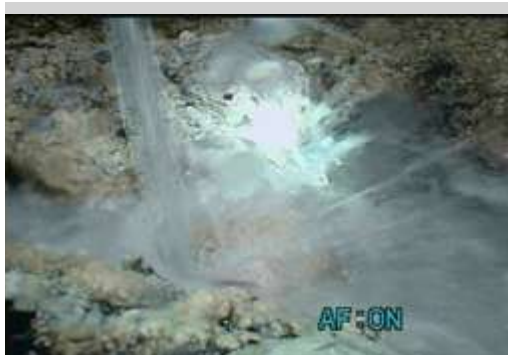
Defect 3

Condition: ☐ Sound ☐ Cracked ☐ Root Intrusion ☒ **Deteriorated** ☐ Leaks ☒ **Debris**

channel debris

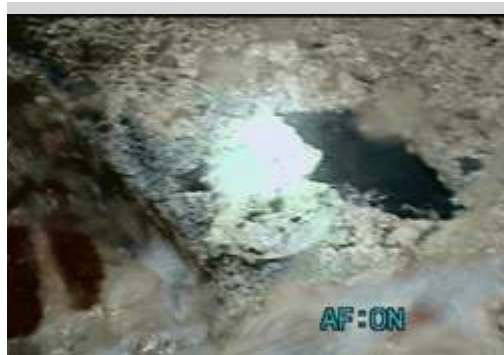
Defect 2

Condition: ☐ Sound ☐ Cracked ☐ Root Intrusion ☒ **Deteriorated** ☐ Leaks ☒ **Debris**

bench debris

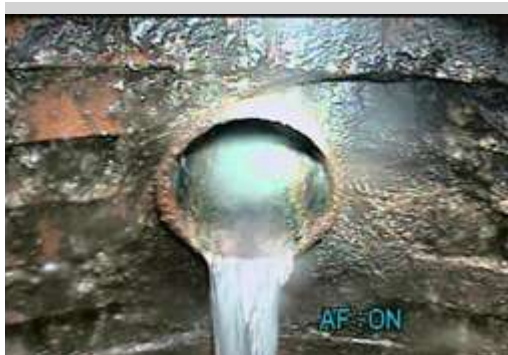
Defect

Condition: ☐ Sound ☐ Cracked ☐ Root Intrusion ☐ Loose Brick ☒ **Deteriorated**

Infiltration: ☐ None ☐ Joint ☐ Cracks ☐ Mortar ☐ Roots ☒ **Wall**

corbel infiltration & deterioration

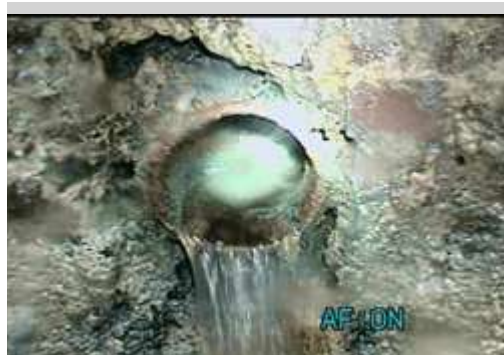
Defect

Condition: ☐ Sound ☐ Cracked ☐ Root Intrusion ☐ Loose Brick ☒ **Deteriorated**

Infiltration: ☐ None ☐ Joint ☐ Cracks ☐ Mortar ☐ Roots ☒ **Wall**

barrel infiltration & deterioration

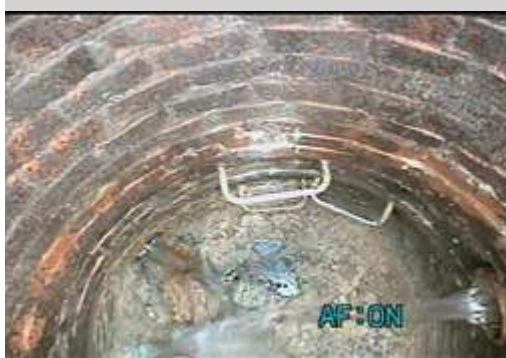
Defect 1

Count: **6** Missing: **3** ☒ **Corroded**

cor. steps
